Localized corrosion behavior of scratches on nickel-base Alloy 690TT

Localized corrosion of scratched Alloy 690TT was studied using scanning electrochemical microscopy (SECM) in 10 wt.% NaOH solution and atomic force microscopy (AFM) after short-time oxidation tests in high temperature high pressure water at 250 °C. The results show that the scratches detected by SECM displayed more extensive electrochemical activity. The scratch groove and the whole deformed region caused by scratching as anode corresponded to the peak of tip current. The oxides formed in 250 °C high purity pressurized water nucleated preferentially at the scratch groove and grew faster than non-scratched surface. The nano-grained scratch groove has more electrochemical reactivity than mechanical twins at scratch banks. The intense localized corrosion could contribute to crack initiation at the bottom of scratch groove.

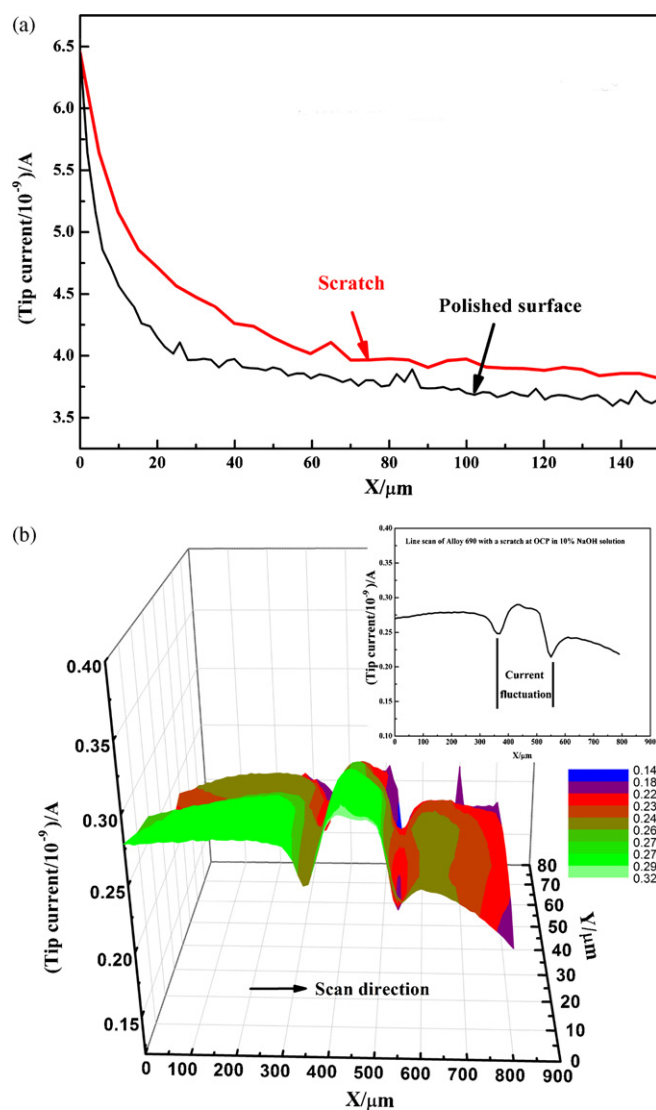
Fig. 3. (a) Approach curves of Alloy 690TT with a scratch at OCP in wt.10% NaOH solution; (b) SECM topography imaging of Alloy 690TT with a scratch at OCP in 10 wt.% NaOH solution. Tip potential: -0.45 vs. SCE/V, tip diameter: $10 \mu\text{m}$, tip-substrate distance: $15 \mu\text{m}$.

The local corrosion of scratches in Alloy 690 was studied using SECM in aerated 10 wt.% NaOH solution (pH 13.8). An SECM approach curve was obtained when the UME moved away from surface in the vertical direction to the surface. In order to keep the UME tip above the center of the scratch groove every time, the tip was lowered in vertical direction and moved horizontally until it slightly touched one of the bumps as described in Fig. 1c according to the CCD camera video. Then the UME tip continued to be moved horizontally with a distance of $50 \mu\text{m}$ which was the half width of the scratch. Finally, the tip was adjusted to the same height before it was lowered and approach curve was measured. As shown in Fig. 3a, the two approach curves achieved while UME was above polished surface and the scratch respectively, exhibited a sharp cur-

However, while the UME tip above the polished surface and scratch was at the same height, the tip current above the scratch was bigger than that above the polished surface. When the UME continued to move up to some distance, it could not collect the signal from local region, only an overall signal from the background. Fig. 3a also indicates that the collected signal above the scratch was sensed at a longer distance. The local current from polished surface could be collected for distances less than $30\ \mu\text{m}$, but above the scratch the local current was collected even for a tip distance of $60\ \mu\text{m}$, which means that the local electrochemical reaction at the scratch was more intense.

An area of $900 \times 80\ \mu\text{m}^2$ with a scratch in the middle was scanned as shown in Fig. 3b. The current map on the scratched surface indicates that there was a current peak above the scratch groove. There were two little current troughs beside the scratch which was smaller than the current on the polished surface as shown in the inset of Fig. 3b. The current at the UME was related to the distance between UME tip and surface [11]. During scanning the UME tip was kept at a constant height above the polished surface. This means the distance between the UME tip and the lowest point of the scratch groove was larger than other positions, so the current at the scratch groove should be much higher than the measured current value. Völker et al. [12] have also found a remarkable increase of tip current over a scratch in low carbon steel surfaces coated with tin because of dissolution of Fe. The increase of current at the UME indicates that corrosion rate over the scratch was faster compared to the polished surface in this caustic solution. Moreover, the tip current above the groove is bigger than that above the two piles beside the groove. It also indicates that the dissolution at the groove with nano-grain structure is more intense than that at the slip bands with mechanical twins. The distance between the two tip current troughs was $200\ \mu\text{m}$ as depicted in the inset in Fig. 3b. It should be noticed the total deformed width caused by the scratch was about $200\ \mu\text{m}$ (Fig. 1a), which indicates that the fluctuation of tip current was strongly related to the deformation.

Scratching created a deformed rough surface (Fig. 1a) including the scratch groove and scratch banks. Based on terrace–ledge–kink (TLK) model of a surface [13], as indicated by the increasing local dissolution current (Fig. 3a and b), the increased activity is associated with the irregular arrangement of Ni, Cr, Fe atoms in crystalline lattice. Atoms associated with a slip plane in presence of short-range order were more readily dissolved into the solution [14,15]. Thus, it is easy to understand the current increase above the scratch

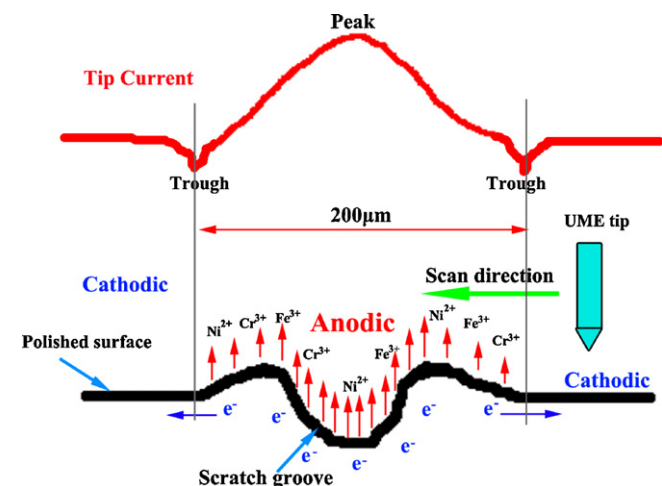
Fig. 4. Schematic representation of collected current at UME tip over one scratch for Alloy 690TT.

ions, and the left free electrons migrated towards to the cathode, the polished surface. At the edge between the anode and cathode, the free electrons density could be the highest and formed the current troughs as shown in Fig. 4. This agrees with a localized corrosion phenomenon which has been theoretically studied and experimentally observed by SVET measurements [17]. The UME tip current gained over scratch also reflects the dissolved microchemical species changes at the substrate/solution interface. However, the reactions occurred at the UME tip are not confirmed yet.

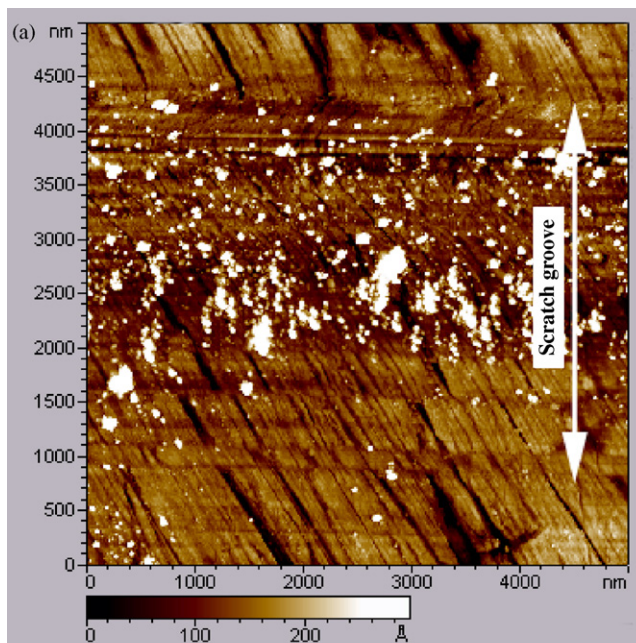
Fig. 5. AFM images for scratched Alloy 690TT after conducting oxidation test in $250\ ^\circ\text{C}$ water for 2 min. (a) 2D oxides morphology; (b) 3D oxides morphology.

Short-time oxidation behavior of scratches in high temperature water was studied using AFM. Fig. 5a shows a 2D AFM image of short-time oxidation of Alloy 690TT with a slight scratch after 2 min of exposure in 250 °C water. Oxides did not homogeneously cover the Alloy 690TT surface with the fine scratch. Oxides preferentially grew at the scratch groove and oxides on the non-scratched surface are not obvious after short-time exposure. Fig. 5b gives a more clear 3D oxide morphology, which indicates that oxide on the scratch groove grew earlier and faster than the non-scratched surface. This is further evidence that corrosion at the scratch sites preferentially occurred in high temperature water.
